Great Barrier Reef

Report Card **2011**
Reef Water Quality Protection Plan

Progress towards targets up to June 2011

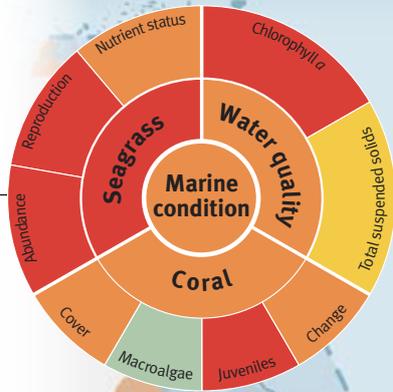
Improvements in catchment management will take time to translate into improved marine condition, particularly given the strong influence of extreme weather events in recent years, including 2010-2011 (see over for details). There is low confidence in the Cape York and Burnett Mary results due to limited data availability and validation.

The overall condition of the reef in 2010-2011 declined from moderate to poor. Inshore water quality was poor overall and varied from moderate to poor depending on the region. Inshore seagrass was in very poor condition overall, and its condition has continued to decline since 2006-2007. Inshore coral reefs were in poor condition overall.

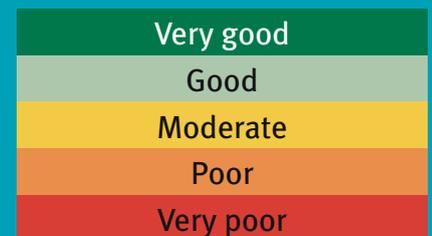
A standardised scoring system was developed for each of the key indicators in the report card. The scoring system is used to assess and communicate the progress towards the goals and targets using the following categories:

The Reef Plan targets are considered ambitious. Therefore, progress that is equal to or exceeds the target is considered very good. Further details on the scoring system for each indicator are outlined in the supporting technical information on the Reef Plan website, www.reefplan.qld.gov.au.

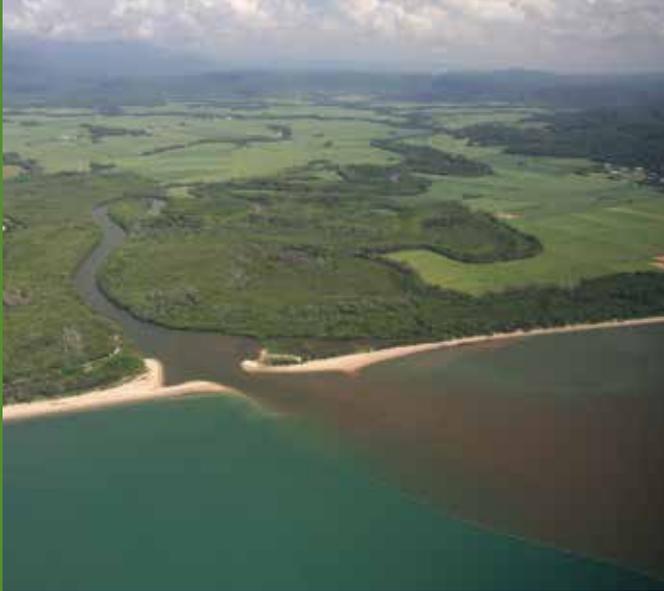
Catchment runoff entering the Great Barrier Reef lagoon, north of Mossman. Photo: courtesy Queensland Government Department of Agriculture, Fisheries and Forestry.

The summer of 2010-2011 was the second wettest on record in Australia. This extreme weather caused flooding in several catchments and much higher than normal discharge from most rivers. A large expanse of the inshore reef south of Mackay was exposed to persistent flood plumes from the Fitzroy, Burnett and Mary Rivers.

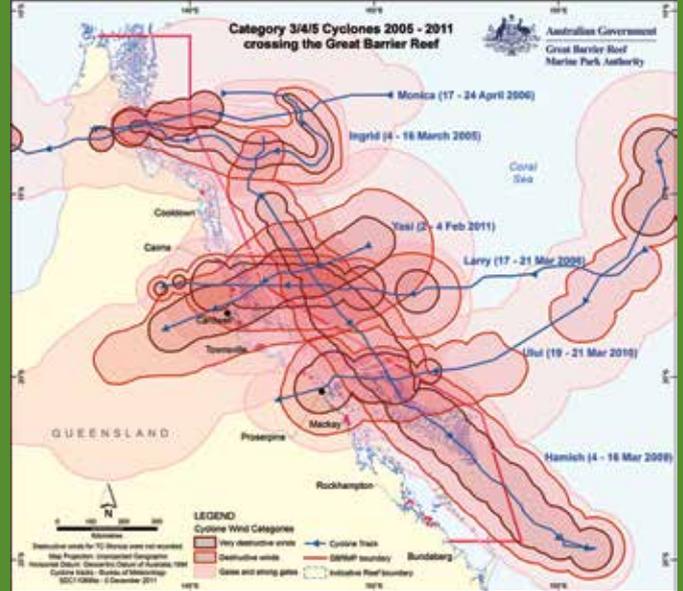
Extent of the Great Barrier Reef impacted by Category 4 or 5 cyclones in the six year period 2005-2011. Map: Courtesy of the Spatial Data Centre, Great Barrier Reef Marine Park Authority.

Tropical Cyclone Yasi, one of the largest and most powerful cyclones to affect Australia since records began, crossed the Queensland coast near Mission Beach in February 2011 causing damage to seagrass meadows and the reef from Cooktown to Mackay. This has led to the poor marine condition in many regions for 2011. Underwater surveys indicate that 15 per cent of the total reef area sustained some coral damage and full recovery will take decades.
